## The Three Bells of First Parish Church

## The Bells of First Parish

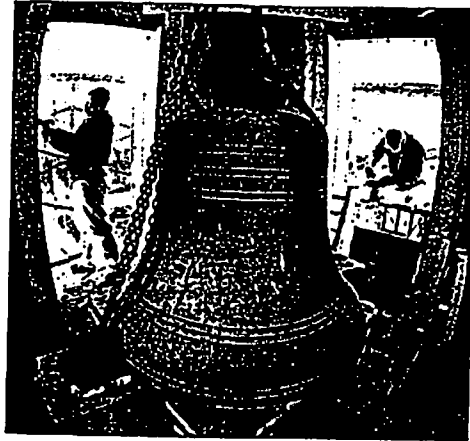
The clapper is of iron and is mounted on an iron staple cast into the crown (top) of the bell. It is held in the staple by an iron pin on which it swings.

The tongue weighs 35-40 pounds and is iron. Over time that constant pounding deforms even that mass of iron, and the original round shape deforms into an egg shape. The ball shaped end of the clapper gets beaten into a flat spot on both striking surfaces of the clapper. Gradually that contact point grows from a desired size, about dime sized, to the equivalent of several silver dollars in surface area.

This then impacts the sound bow over a larger area and is not healthy for any bell. This growing impact point is one reason for a bell to change its tone or even to fail. In 1983 the blacksmiths at Sturbridge Village forged the clapper back to the original round shape by heating it to an orange color and pounding it. They pounded away for some time to undo the wear of one and a half centuries.

A danger point in many bells is the staple, which will rust over time. Iron expands 6 percent when it rusts. This expansion is called oxide jacking and can introduce stresses that have been known to crack a bell.

In 1984 a new wooden wheel was installed, along with a new wooden cradle for the entire assembly. All of the cast iron was sandblasted, primed and painted with epoxy-type black paint.

The clapper must swing true within the barrel of the bell. This means it should contact the same point on the sound bow every time it strikes. If the staple wears or the clapper pin wears, the clapper can move side to side in sloppy fashion with sufficient strength to eventually self-destruct. In 1984 the Holbrook clapper, after about 150 years of use, had worn away enough metal to have excessive sideways motion. I acquired a special stainless steel alloy from the Statue of Liberty restoration project that is designed to withstand our salt air environment. From it I fabricated and installed two large washers to keep the clapper flying straight.

In 1984 we also turned the bell 180 degrees to balance the impact of weathering, installed a new wooden wheel and gave the whole assembly a new wooden cradle. All of the cast iron was sandblasted, primed and painted with epoxy-type black paint. I installed grease fitting, making the task of lubricating the moving parts easier.
